# Modifications for the Kenwood TR-7400

## Service Notes on TR-7400A

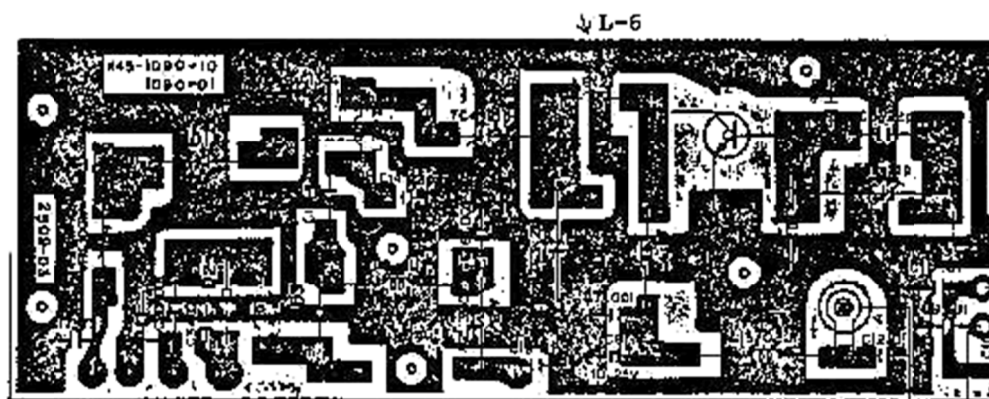
There may be some cases of arcing to ground beneath coil L-6 at the collector of Q-2 (2N6083) inside the final unit X45-10-90-10. This is due to minute differences in the circuit board trace dimensions and a residue of flux on the board.

If this should occur, remove L-6 and clean all traces of carbon and flux from the circuit board. Resolder the edges of the tracer and remove any flux left from soldering. Modify L-6 as shown:

reinstall L-6 and check for rated output. A slight retuning of TC-4 may be required.

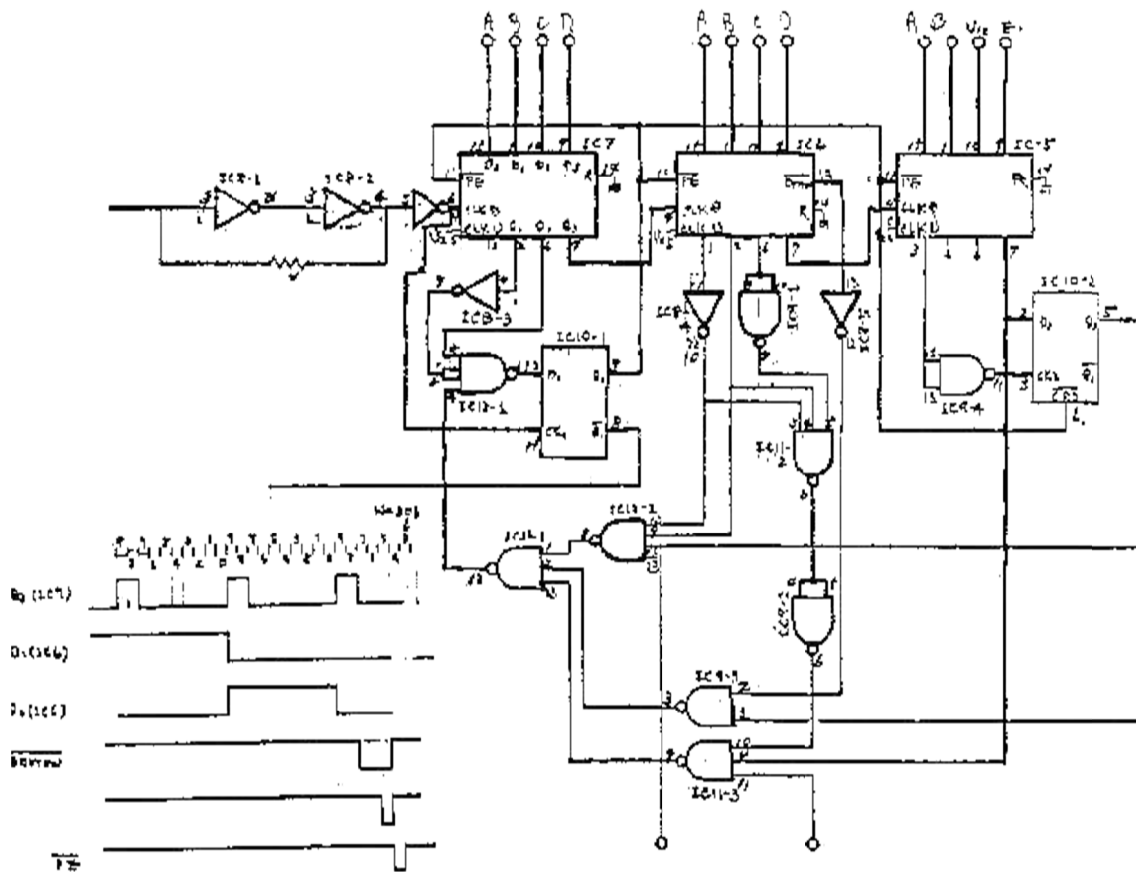
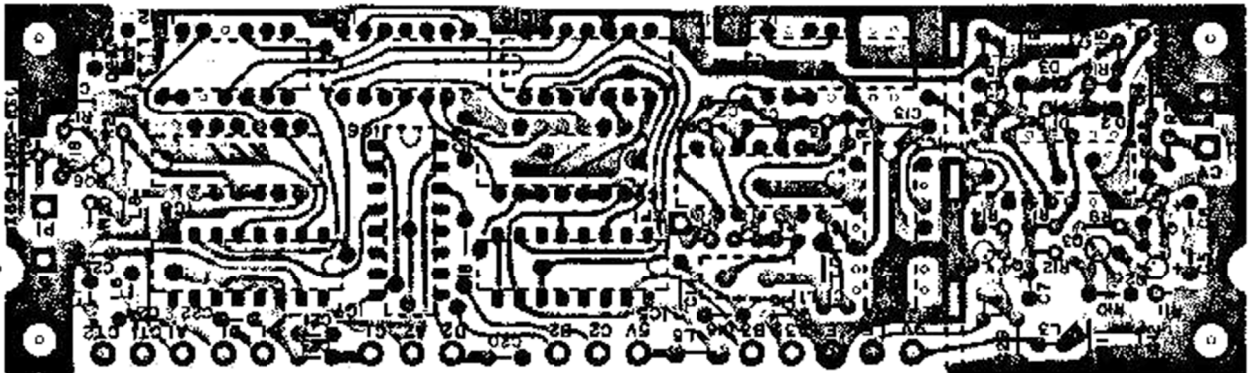
Service bulletin no. 32 (19-1-1979)

There was a temporary production change in the PO Unit of the TR-7400A. This change effected the 73XXXX and 74XXXX series units only. The change was made because of the Motorola MC-4016P IC was not available. The Texas Instruments SN74LS192 IC was used as a replacement. It is not a direct replacement, though. It was also necessary to change IC-8 from a TD-3400AP to a TD3404. This series of PO Units is easily recognized because of the three SN74LS192 IS's are mounted in sockets instead of being soldered in place. The PC board was changed to J25-2512-03T instead of J25-2512-03 for this change. The schematic is shown below.

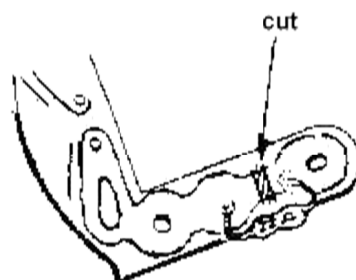
The life of the meter Lamp in the TR-7400A may be extended by inserting a 22ohm 1/4W resistor in series it. This resistor may be conveniently mounted on the circuit board that holds the lamp by cutting foil path on one side of the lamp and soldering the resistor across the break in the foil path. A drawing of the circuit board with the resistor added is shown below.
